# SITE REMEDIATION IN NIGERIA: PROVEN AND INNOVATIVE TECHNOLOGIES (RECOVERY OF FREE HYDROCARBON FROM SOIL/GROUNDWATER)

Conference Paper · November 2014

Oluwapelumi O. Ojuri<sup>1</sup> Samuel A. Ola<sup>1</sup> Olaolu G. Fadugba<sup>1</sup> and Micheal A. Uduebor<sup>1</sup>

<sup>1</sup>Department of Civil and Environmental Engineering, Federal University of Technology, Akure, Nigeria

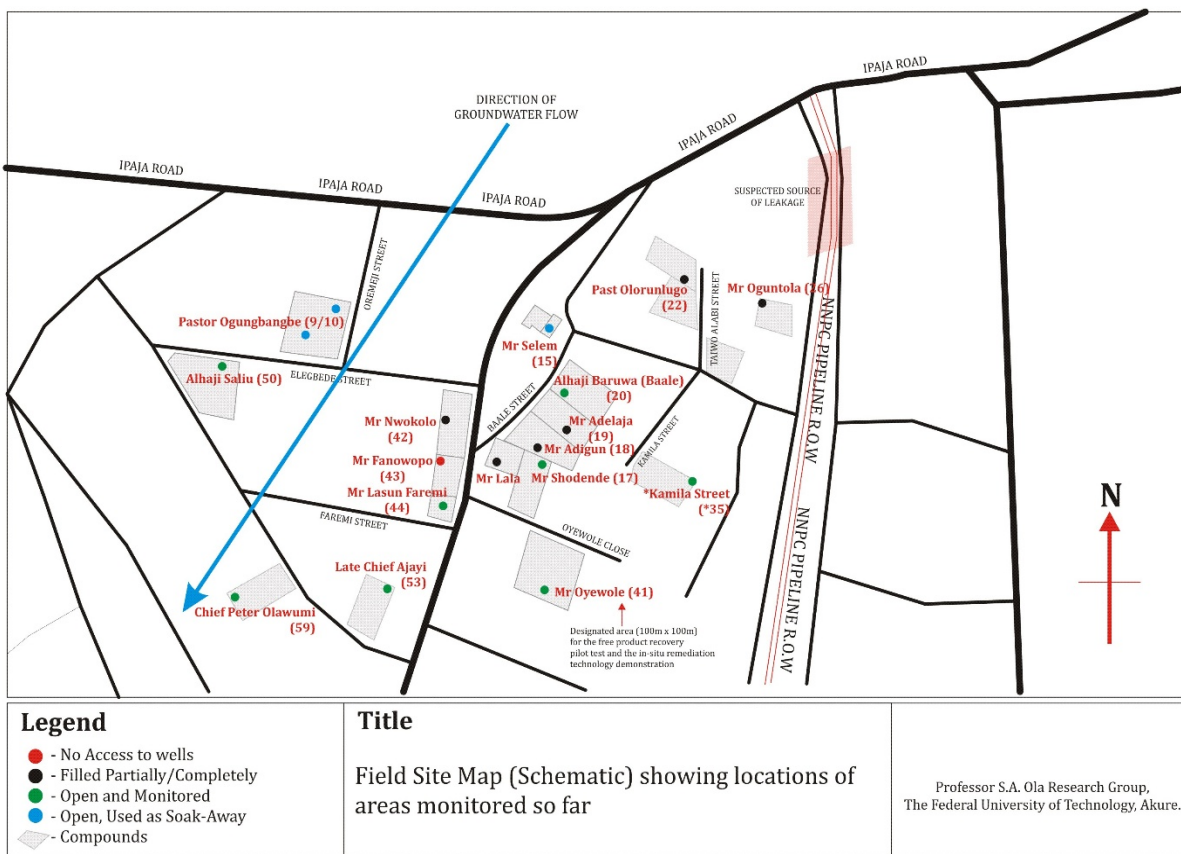
It was realized that most compounds had carried out the filling and sealing up of their respective wells. Only three out of the ten wells within the earmarked pilot test scheme were still opened, others wells had been sealed while some others visited had been utilized for effluent discharge and refuse.

Fig 3 Demarcation of Pilot Test location showing state of the earmarked wells for the pilot recovery test

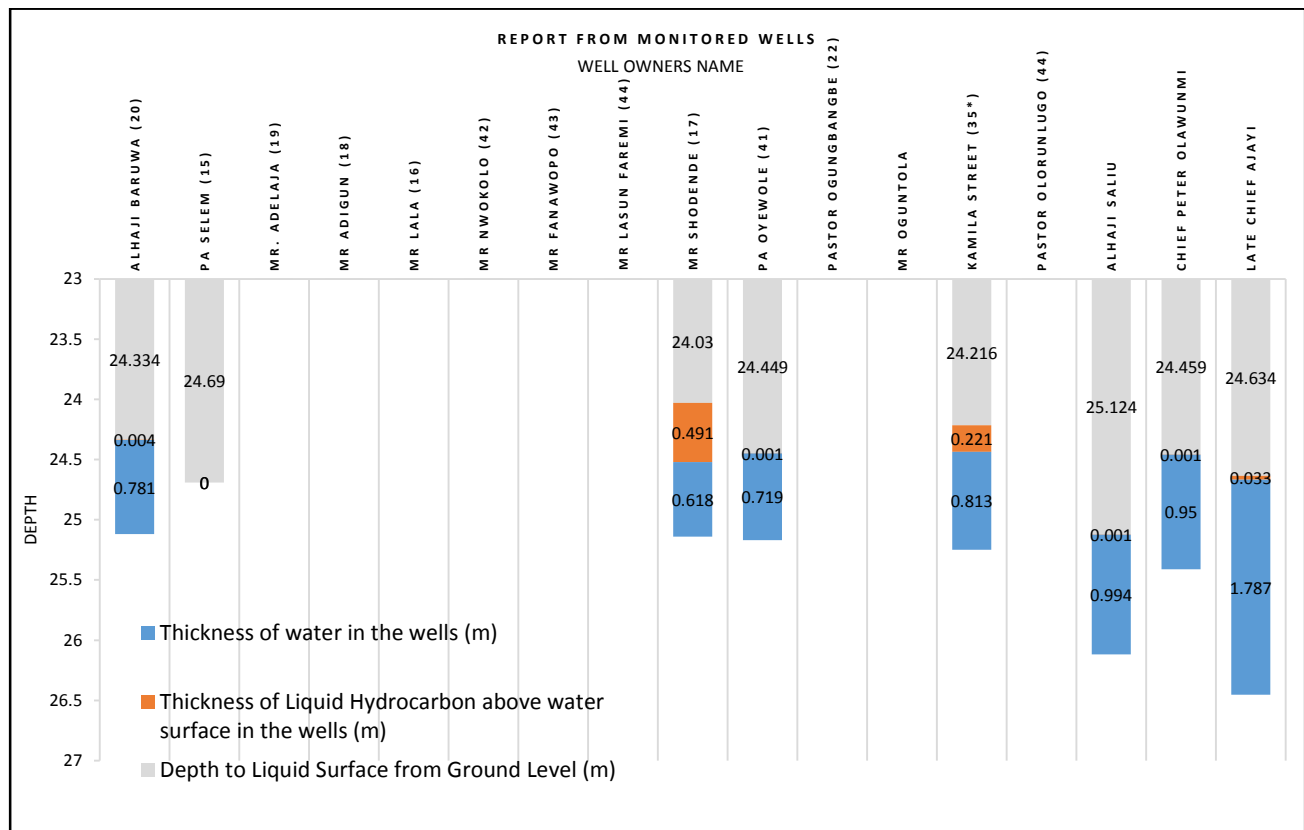
After meeting with the local people and establishing contact with necessary Agencies, Monitoring and Oil skimming started from Mr. Shodende's compound which had a total free hydrocarbon product thickness of 0.52m totaling about 1.33m<sup>3</sup> of Liquid Hydrocarbon. Other wells monitored within and outside the pilot test area had between 0.22 to 0.001m of liquid hydrocarbon

Fig 4 Reports of all wells monitored showing the various thicknesses of free hydrocarbon product and water

The oil skimmer was employed in recovery the free product from the wells where it had been discovered. Skimming essentially started from the well with the highest amount of free product discovered (Well 17) and progressed to others which had just a sheen on the surface of the water within the wells. The placement of the belt/yoke assembly was adjusted to ensure that it was within the hydrocarbon product. Samples were collected at one-hour intervals and analyzed. An improvised bailer was combined with the oil skimmer to increase the rate of recovery of free product. At Well 17, about over 84 Litres of free product hydrocarbon was recovered.
